### CONDITION REPORT ON THE STAINED GLASS WINDOWS AT THE CHURCH OF ST MICHAEL & ALL ANGELS – SANDHURST

Report compiled by: Robert Holloway A.C.R & Laura Hobson of Chapel Studio stained glass

November 2017

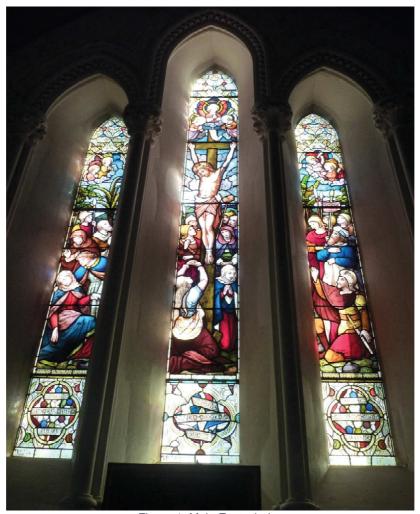
Figure 1: Main East window

**Lead Matrix**: Is comprised of a mixture of 3/16 and  $\frac{1}{2}$  flat profile leads, although the lead is oxidised which is to be expected in a window of this age I could not see any bowing or sagging of the matrix. There were no obvious cracks in the joints either.

**Structural support:** Each of the outer lights have 5x 3/8 round support bars and the centre light has six. These are starting to rust but are not causing damage to the mullions currently.

**Glass:** The glass is in reasonably good condition. There is no sign of corrosion but there are multiple breaks. Some of these are single cracks which can be an indication of the lead matrix starting to

become weak. The right hand light has a section with multiple fractures running across three sections of glass around the kneeling soldier and running through his face; these breaks look like it has been caused from an impact from and object of some kind.

**Recommendations:** This window will need to be removed in the near future for re-leading and repair. It's not the most urgent in the church but should be budgeted for in the rolling programme of repair in the church. The paint loss will continue to get worse as the weatherproofing cement is starting to fail on this window allowing moisture onto the internal surface. There is evidence of the lead matrix starting to deteriorate in the form of the single cracks in the glass. Currently this is not too bad but this occurrence will continue to progress if not addressed.

I would recommend that this window be assessed again in 3-5 years' time.

Once the funds do become available this window would benefit from being removed for full releading and repair. The window is showing signs of fatigue in the form of single stress cracks in the glass and the weatherproofing cement is becoming friable. The matrix isn't bowing yet but the stress cracks will continue and water ingress will become more of a problem. The missing areas of inscription can have backing plates attached with the missing detail painted onto it bringing back the legibility of the inscription whilst being a completely reversible technique to. We can then also repair the cracked glass with the most up to date conservation methods which would be resin repair for the broken solders face and copper foil repairs for the single cracks in the backgrounds or drapery sections of the windows. We can also look to stabilise the painted pigment and re-weatherproof the window preventing any more moisture build up. The support bars can also be replaced with new non-ferrous bars to prevent any future damage to the stonework at the same time.

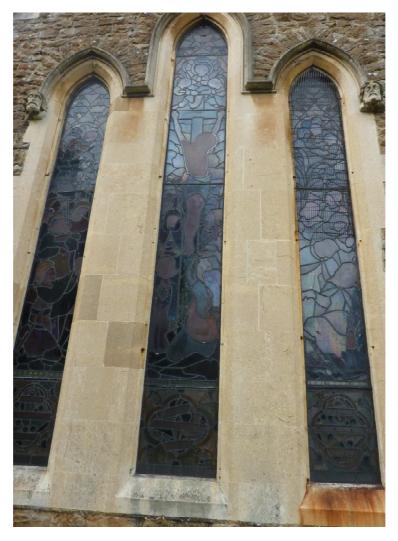
**Masonry internally and externally:** The masonry both internally and externally appears to be in good condition. There is some staining presumably from an old corroded wire guard that has since been removed.

Figure 4: Detail of the external stonework surround of the window

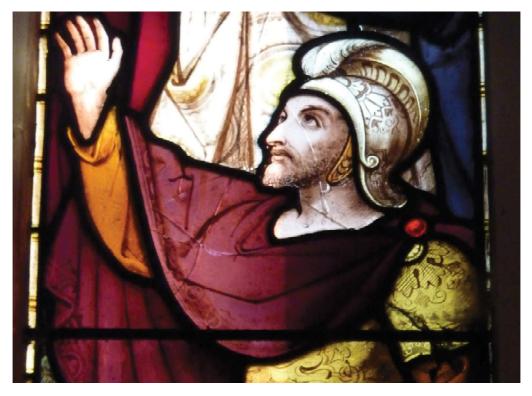
Figure 5: Detail of the fractured sections of glass in panel 3b

The multiple broken section by the soldier in panel 3 b is currently secure and should continue to be monitored for any worsening or instability of the cracks.

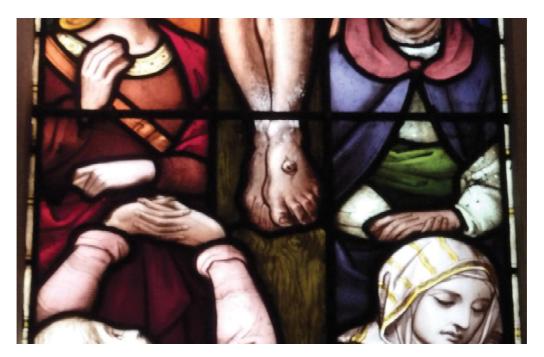
**Painted pigment:** There is some paint loss in this window, most noticeably in the base panels of each of the three lights. The memorial inscription is very badly faded and the extent of paint loss means that the legibility is affected. There are also some localised areas of fading of the pigment around the bars and the feet of Christ. This is where moisture builds up and I think it has started to attack the pigment.

Figure 7: Detail of the fading of the pigment around the bars where moisture has built up.

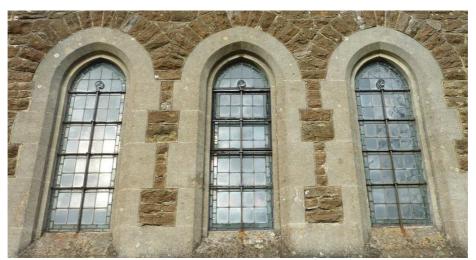
Figure 8: No access internally for the inspection so assessed externally.

**Lead Matrix:** ¼ round which is in good condition.

**Waterproofing cement:** This appears to be in good condition I could not see any evidence of it crumbling out from underneath the lead flanges.

**Recommendations:** This window is currently in good condition and does not require any restoration. The ferrementa would benefit from being brushed down and re-decorated with the appropriate black finish metal paints.

I would recommend that this window be assessed again in 10 years' time.

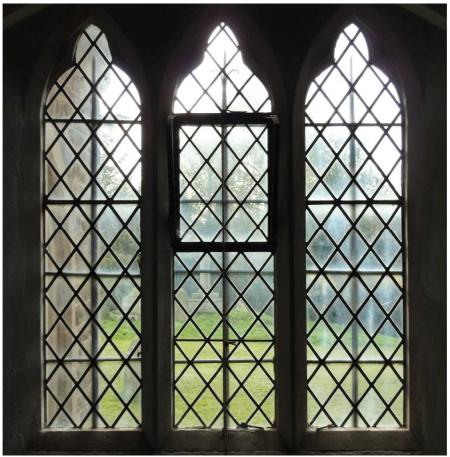
Figure 9: Window in the Clergy Vestry on the south side

**Lead Matrix:** The outer lights are glazed in a 3/8 flat profile lead which although its oxidised is in reasonable condition and the centre light has been re-leaded at some point and is in good condition with a slightly thinner width lead of 5/16".

**Structural support:** The external ferrementa bars are in good condition currently they are not causing any problems to the stonework at the moment. The internal bars are starting to rust.

**Recommendations:** This window is currently in reasonable condition, I would recommend that the ferrementa bars be brushed down and re-decorated in the appropriate metal black paint and the window assessed again in 10 years' time.

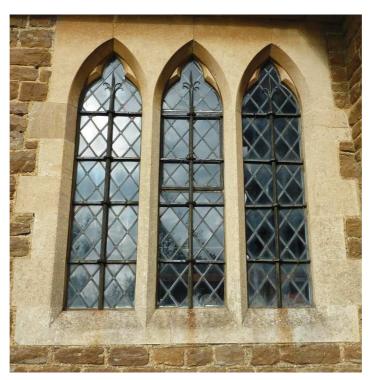
Figure 10: External view of window s III

**Glass:** Clear sheet glass, I could only see one cracked diamond in the right hand light. There is no evidence of any glass corrosion.

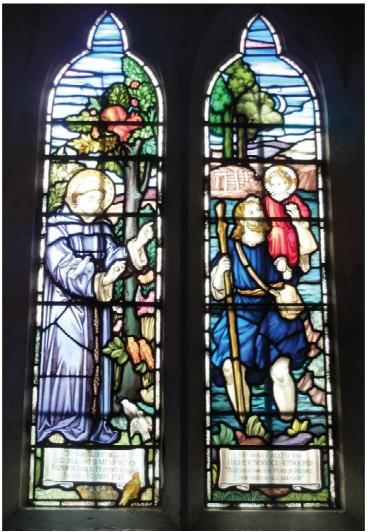
Figure 11: Window s IV South Aisle

**Lead Matrix:** The matrix is in reasonably good condition. I could not see any areas where it is bowing or sagging. There were no obvious cracks in the lead joints. The panel is comprised of ¼ round profile lead.

**Structural support:** Externally each of the lancets has the original ferrementa bars which are starting to rust but are in reasonably condition. Each light has 3 x 3/8 round support bars which are also reasonable condition.

**Recommendations:** This window is in good condition currently, the pointing and the crumbling plaster should be monitored at the base of the window internally but the stained glass does not require restoration at the moment. The window should be assessed again in 10years time. The ferrementa would benefit from being brushed down and re-decorated.

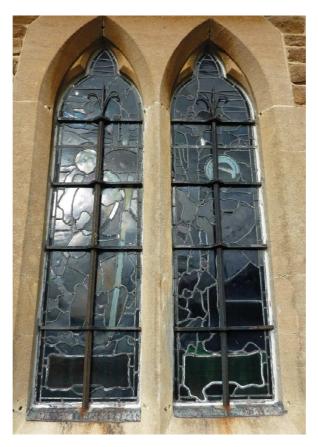
Figure 12: External view of the ferrementa which is starting to rust in places and the lead condensation trays.

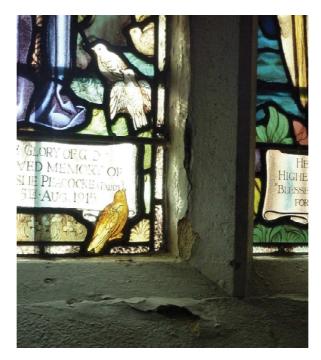
**Masonry internally and externally:** The surrounding stone is in good condition but there is some crumbling loose pointing along the mullion of the left hand light. The pointing mix is very white looking externally so this could be a problem caused by the mix or caused by incorrect application which has allowed some water ingress.

Figure 13: Detail of the crumbling plaster and mortar at the base of the central mullion.

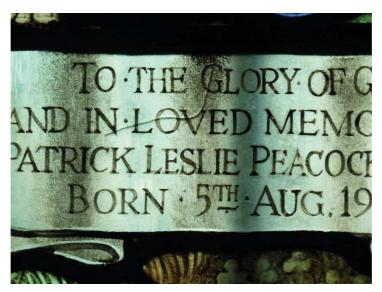
**Glass:** There is some really good quality antique handmade glasses in this window. There is no evidence of corrosion on either surface. Unfortunately there is a single crack running down the inscription of panel 1a. The crack is stable and from what I could see there was no evidence of water ingress.

Figure 14: Detail of the crack in panel 1a.

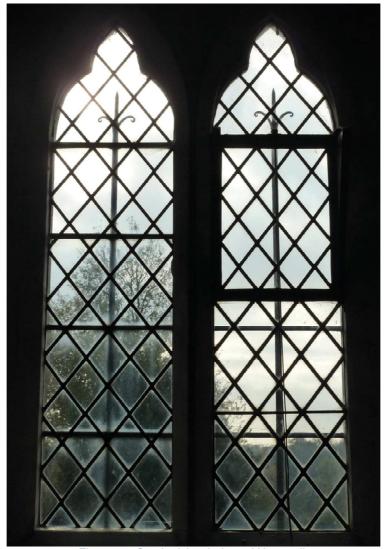
Figure 15: South aisle window s V internally

**Lead Matrix:** Although there's two different lead came sizes and dates, the right hand light is older with 3/8" lead and the left hand is 5/16" and has been re-leaded at some point. Both windows are still in reasonable condition. There is some bowing in the casement panel but that's to be expected as there is no support bar and it's still a working hopper. The lead is oxidised but I could not see any visible cracks in the joints.

**Structural support:** Each light has external ferrementa which is starting to rust as is the casement. You can see the rust staining the stone sills as the upright enters the stonework. It's not causing any damage currently. The casement is also rusty internally as are the support bars. This has caused some of the pointing to come loose out of the grooves but is very localised and has not caused damaged to the stonework.

**Recommendations:** This window should be assessed again in 3-5 years' time but should be monitored for signs of water ingress and further loss of pointing around the internal bars. Brush down & Re-decorate the ferrementa. The broken wing of the casement should be replaced with glass to match insitu whilst others works are being undertaken

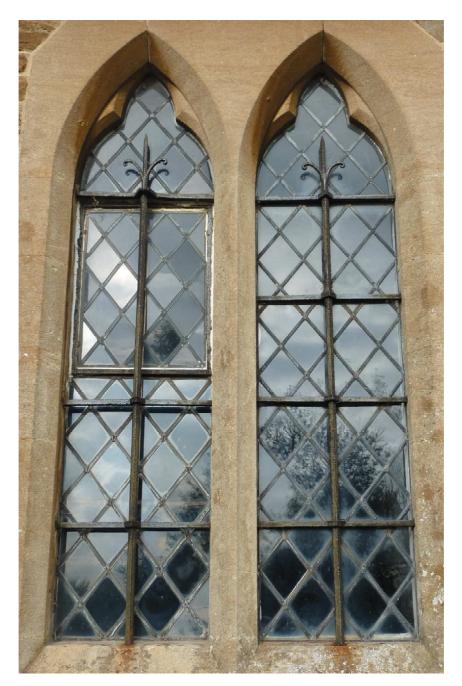
Masonry internally and externally: The stonework around this window is in good condition both internally and externally. There is some crumbling of the pointing at localised points around the support bars internally. This is due to the rusting of the bars. Externally there is also some rust staining at the sill where the uprights of the ferrement bars enter the stonework. This will need to be continued to be monitored as this will only continue to get worse as the metalwork continues to rust and unfortunately rust jacking is inevitable. If further damaged starts to occur then the bars, casement framework and the ferrementa will need to be removed and the support bars replaced with non-ferrous bars to match the width and profile of the original and the ferrementa will need to be cut and re-tipped with stainless steel ends. The picture below details the staining of the sills from the rusting metalwork.

Figure 17: Window s V Externally.

**Glass:** Clear sheet glass with no movement or texture to it. The right hand eyelet wing of the opening hopper is cracked. No evidence of corrosion on either side of the glass.

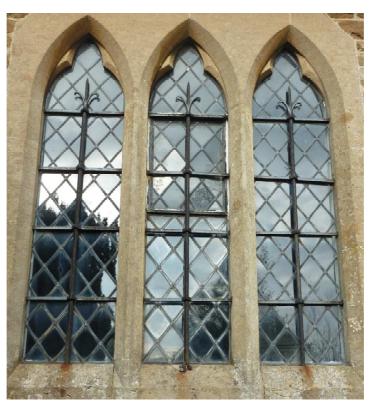
Figure 18: External view of window s VI

**Waterproofing cement:** The centre light cement is starting to crumble in places. It has become friable and is pushing out from underneath the lead flanges in places. The outer lights seem to be in better condition the cement is still intact and not crumbling.

**Masonry internally and externally:** The stonework surrounds are in good condition currently. There are some localised areas where the pointing is loose at the base of the centre light much like the previous diamond light on the south aisle.

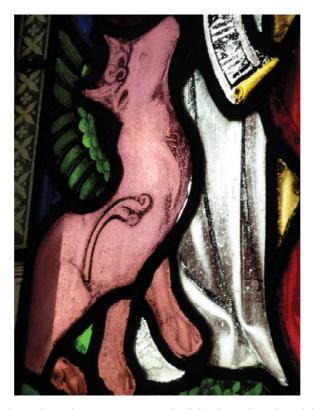
is pulling out from underneath the lead flanges. There are cracks in the joints and the lead is heavily oxidised.

Figure 24: Detail of panel 2c where you can see daylight along the edge of the glass and lead.

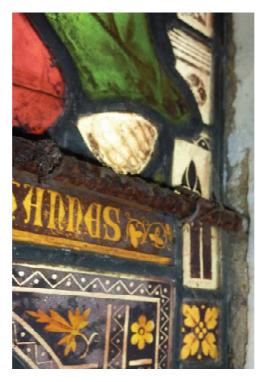
**Ties:** The panels are attached to the internal support bars with copper ties some of which appear to have snapped from the panel due to the sagging of the matrix.

Figure 25: Detail of the copper ties and the rusty support bars.

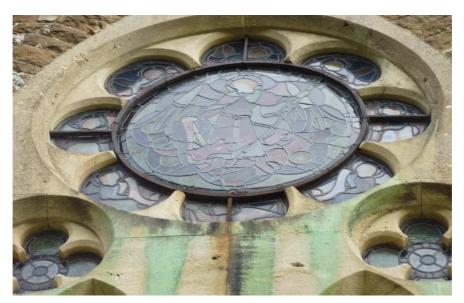
Structural support: The rose tracery has a circular metal frame externally and a single support bar running through the main circular panel internally, this appears to be in a corroded rusty condition. The main lights each have four round 3/8 bars and these are also rusting too which you can clearly see looking at figure 25 above. They are not at present causing rust jacking to the stonework that I could see but if allowed to continue to rust further then damage to the surrounding stone is inevitable unfortunately. The panels appear to be buried quite deep into the stonework. Quite a lot of the clear outer borders are hidden in the grooves which means the panels are in very tight. The pointing has fallen out in areas along the internal mullions again I think this is localised to around the support bars due to the rusty condition of them and expanding at those points resulting in the pointing pushing and crumbling out. You can see the staining of the stonework externally also from the rusty framework.

Figure 26: Detail of the external framework of the rose tracery. There is also staining which i don't think is just from the existing frame i think there was old corroding wire guards at some point which have been removed which has caused the green staining.

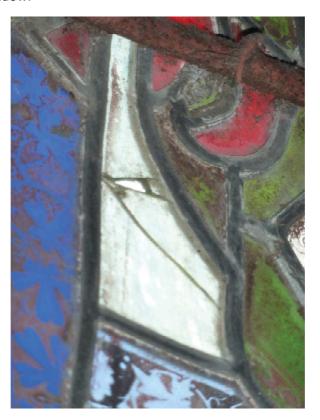
Figure 27: Detail of a broken section of glass with missing fragments in panel 2b

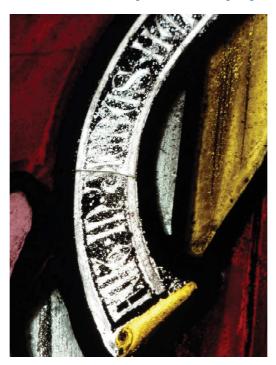
Figure 28: Detail of a single stress crack and also the severity of the paint loss occurring on the very pale green almost white looking glass in panel 2d.

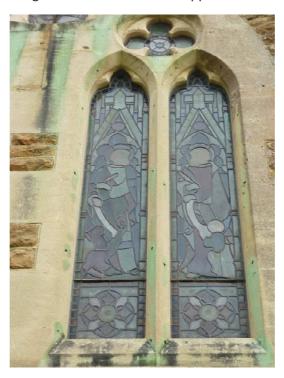
**Protection:** There has been some wire guard protection previously just like most of the other windows as you can still see the fixing holes in the surrounding stonework and in this window you can see the typical green staining of the stonework that happens as the wire guards start to corrode.

Figure 29: detail of light a & b externally where you can clearly see the previous green staining and fixings from old guards.

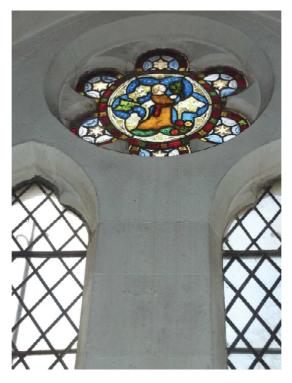
Waterproofing cement: The cement in the left hand light and the base panel of the right hand light is stable. The right hand head is friable and you can see its pushing out from underneath the lead flanges. The cement in the tracery is failing. You can clearly see just like the main west window the drip marks running of the sill of the tracery down the wall from the water ingress as a result.

Figure 31: Detail of the drip marks visible running down from the wall from the sill of the tracery.

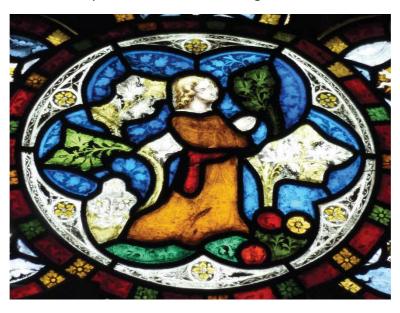
Figure 32: Detail of the central roundel if the upper rose tracery. You can see some single cracks most noticeable in the kite shaped outer border sections and the red scarf.

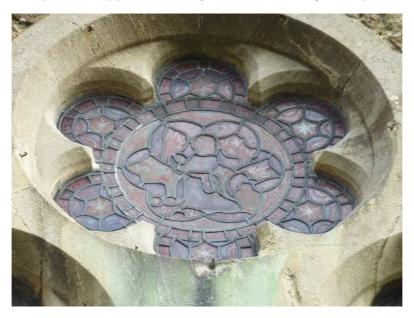
Painted pigment: The painted pigment is in poor condition for the same reasons as the main west window, however there is a large amount of pigment painted on the outside of the window, a good 90%. Looking externally this is very porous looking and is contributing to the paint loss.

Figure 33: External view of the rose tracery where you can see the amount of painted pigment that is exposed to the elements and the porous quality to it as a result.

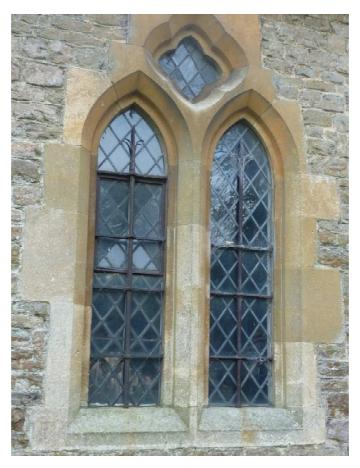
Figure 39: External view and you can clearly see the ferrementa bars are rusting as is the casement framework.

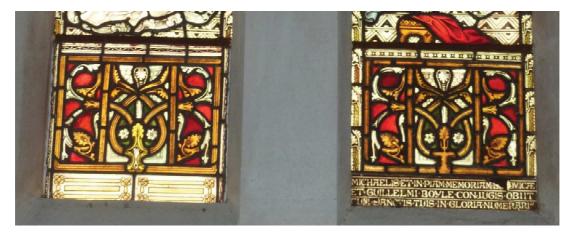
fragments to be kept or repainted as there is just a blank matted section in place now. You can see where they have tried to save the original glass but the arrangement is different and so is the border work.

Figure 41: Detail of panels 1a & 1b where there has been previous restoration of the left hand base panel

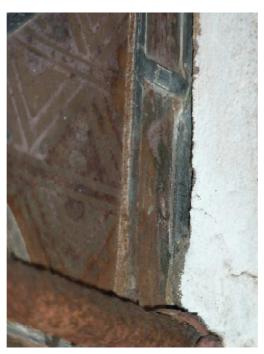
Structural support: Each light has 3 x 3/8 round support bars which are rusty and as a result are starting to crumble the pointing at the point they bars enter the stonework on either mullion.

Figure 42: Detail of panel 2b along the right hand mullion where you can see the missing pointing

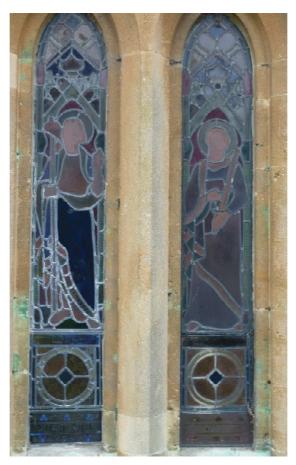
**Previous interventions:** The main base panel of the right-hand light has been repainted at some point probably due to vandal damage of some kind. As it appears that a large section has been redrawn and repainted as its slightly different to the left hand light. You can see more clearly from looking externally as to where the panel has been re-leaded.

Figure 46: External detail of the windows where you can see the lower section of the left hand looking from the outside where it has been previously repaired and re-leaded.

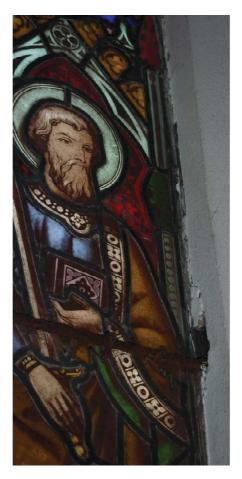
**Structural support:** Each of the lights have 2 x ½ round bar. These are rusty and are causing the pointing to come loose and crumble out of the grooves. They are not damaging the stonework at this point but they will start to cause rust jacking if allowed to corrode further.

Figure 47: Detail of missing pointing due to the corroding bars.

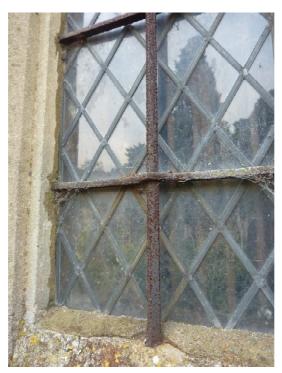
**Masonry internally and externally:** Externally the stonework is sound there are small areas where the pointing is loose along the left hand side of the central mullion. This could be from the rusty ferrementa bars expanding and contracting with rust and causing the pointing to crumble.

Figure 51: Detail of the base of the left hand light where you can see the rusty condition of the ferrementa bars and also the internal grilles
