### CONDITION REPORT ON THE STAINED GLASS WINDOWS AT THE CHURCH OF ST MICHAEL & ALL ANGELS – SANDHURST

Report compiled by: Robert Holloway A.C.R & Laura Hobson of Chapel Studio stained glass

November 2017

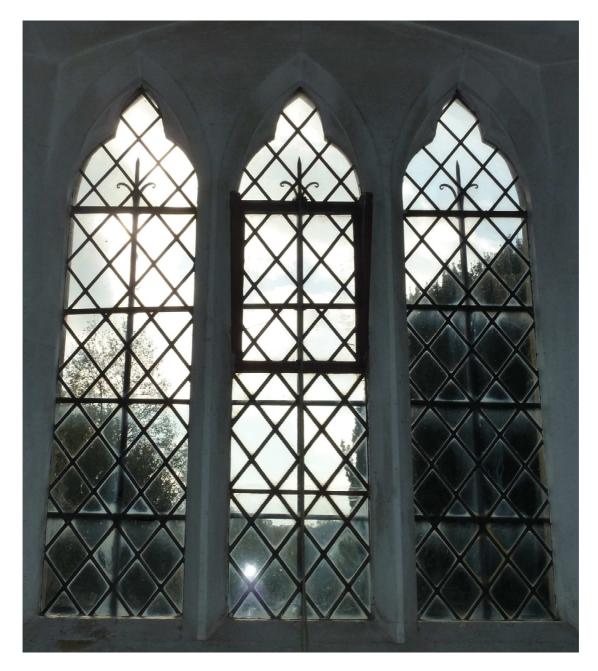
**Access to Window:** Good access both internally and externally, would require a double ladder to reach the top of each light if works are required.

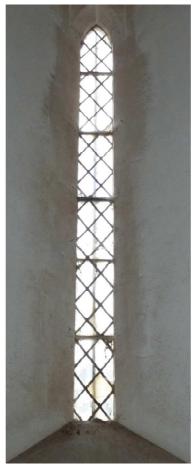
Figure 19: Window s VII tower window

**Access to Window:** Would require a triple ladder to reach the top of the window but there is good access both internally and externally. There is a sloping sill and the sill is 2 ½ ft. deep.

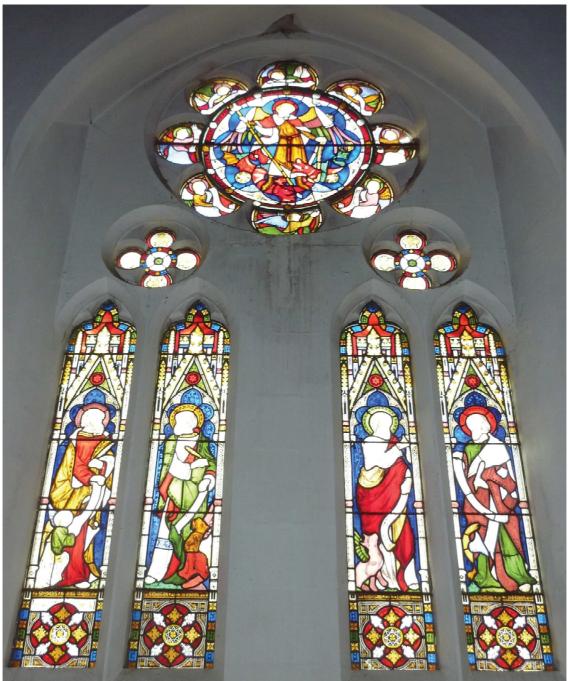
Figure 22: Main West window

Access to Window: Would require a tower scaffold to reach the rose tracery section of the window

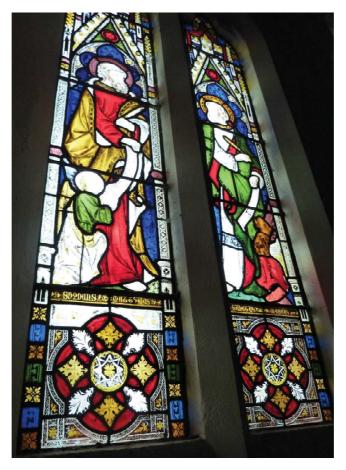
Figure 23: Detail of the bases of lights a&b

**Previous interventions:** None noted.

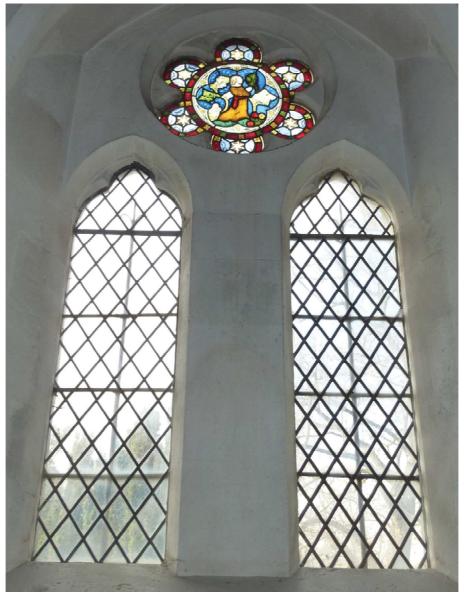
Figure 30: Window nX looking from ground floor internally.

**Access to Window:** Good access but would require a tower scaffold both internally and externally to reach the top of the windows. 2.4 meters up to the sill from the floor

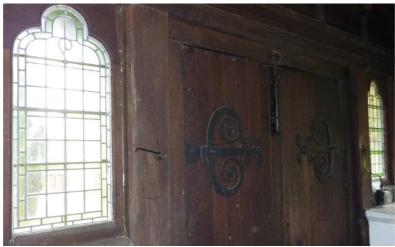
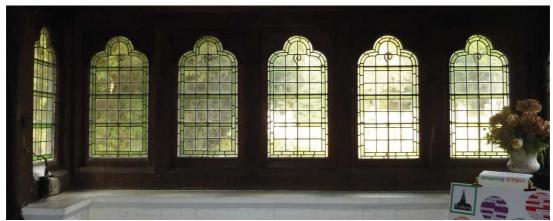
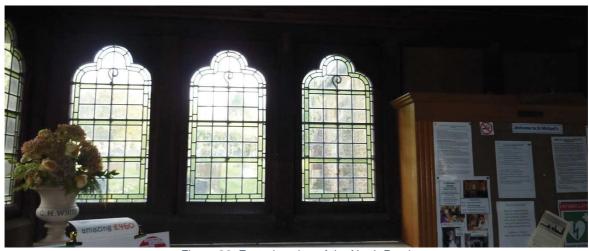
Figure 34: West elevation of the North Porch

Figure 35: North elevation of the North Porch

Figure 36: East elevation of the North Porch

Access to Window: Good access apart form the last two panels on the east elevation which is obstructed by a large cupboard. Would require a small pair of step ladders to reach the top of each panel both sides.

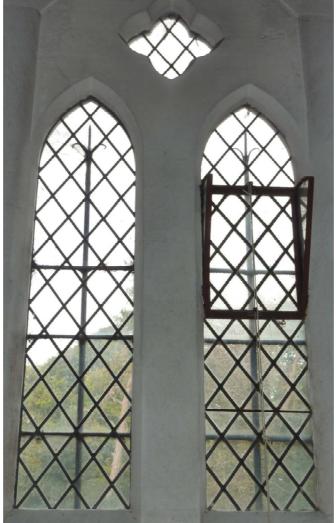
Figure 38: Window n VIII looking from ground floor internally

Access to Window: Good access would require a double ladder to reach the top of the window

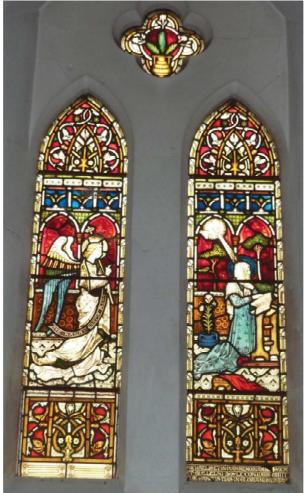
Figure 40: Window n VII looking from the ground floor internally

**Access to Window:** Good clear access but would require a double ladder to reach the top if the tracery

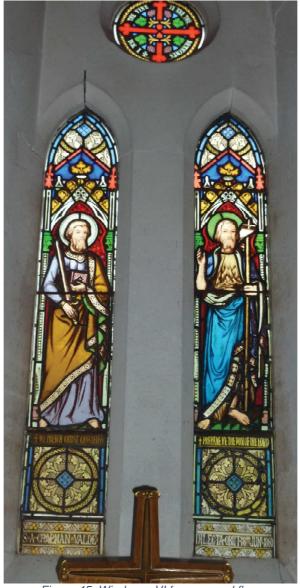
Figure 45: Window n VI from ground floor

**Access to Window:** There is a piano in front of this window but could get a ladder up. Would require a double ladder to reach the top of the window.

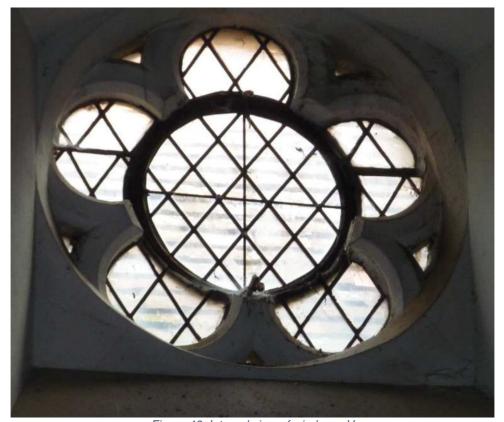
Figure 48: Internal view of window n V

**Access to Window:** This is a higher up window technically at clerestory level. Would require a tower scaffold to carry out any repairs. Could see what the access is like externally as it would be from the roof of the organ loft.

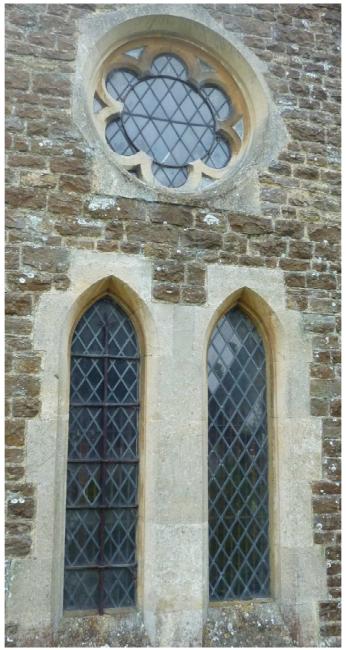
Figure 49: External view of window n IV

**Access to Window:** I could not get internal access as this window is behind the organ but there is good access externally.

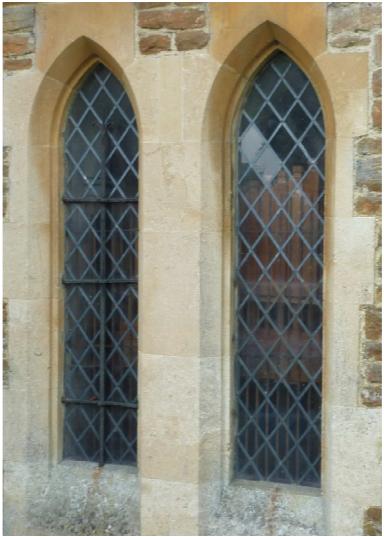
Figure 50: Window n III looking externally.

**Access to Window:** Internally this window has restricted access due to the organ and there appears to be an internal screen up against the window. Externally the access is good.

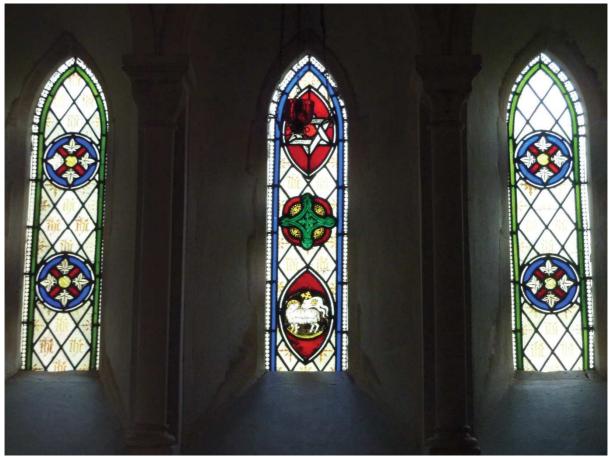
Figure 52: Pressed quarry windows in the east elevation of the High Altar.

**Access to Window:** Good access both internally and externally would require a small pair of steps to reach the top.
